Structural Safety Inspection

Factory Name	Eve Dress Shirt Limited	Accord ID	11346
Factory Address	Anowar Jung Road, Holding #219, Ward # 05, Block #A, , Ashulia, Savar.		
Inspection Date	10/04/2014		
Date of Review Inspection	25-Mar-18		
Inspected by	Md. Kabirul Islam

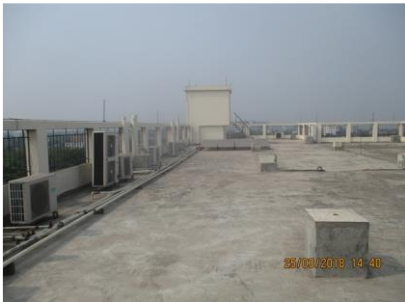
Item No	Accord Observation	Accord Recommendation	Accord Timeline	Final Action Plan	Final Timeline(DD/MM/ YYYY)	Comments after Physical Inspection	Progress Status	Pictorial Evidence
2	There were two water tanks observed on the roof. Each of the two tanks had a 2000 liter capacity.	Engage a qualified structural engineer to confirm and document that provisions have been made to accommodate concentrated loads. If provisions have not been made, have a qualified structural engineer develop a remediation plan.	6/29/2014 12:00:00 AM	Completed (As per Alliance approved Structural Design Report on 20.06.2017)	10/02/2015	On 15th Nov-2015: The factory engage an engineering firm to prepare design report. Factory management committed to us within 15th December 2015 will submit all documents to ALLIANCE structural team. On 11th Dec-2017: During inspection it was observed that two plastic water tanks have been removed from roof. On 25/03/2018: Corrected from previous follow up inspection. No plastic tank is observed on roof.	Corrected

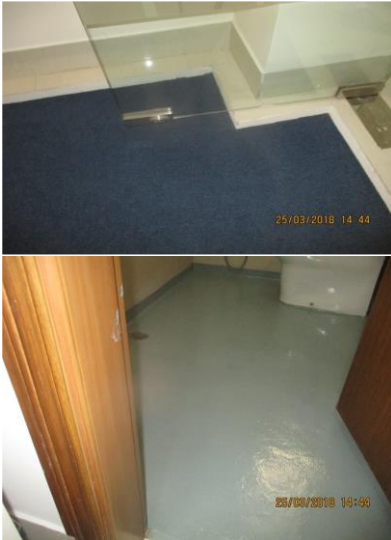
3	Bonded wear house was overloaded in 3F of main building. It was recommended to reduce the load up to allowable limit immediately. The load capacity has not been analytically confirmed and certified by an Alliance-qualified structural engineer.	Have a qualified structural engineer confirm that capacity to support the load is available. Load Plans complying with Alliance Standard Part 8 Section 8.20.4.3 should also be developed.	6/29/2014 12:00:00 AM	Completed	18/03/2015	On 15th Nov-2015: load plans were not produced yet but they maintain loading 2kpa except store area in 5th & 3rd floor. Up to finalize design report the factory should be maintain 2kpa. On 11th Dec-2017: DEA has been accepted from Alliance on 20th June 2017. As per accepted some remediation works (demolition work) were required to be implemented and during inspection it was observed that factory management completed all remediation works except in two toilet areas of 3rd and 6th floor. Factory management must complete all the remediation works. On 25/03/2018: DEA was accepted from ALLIANCE on 20th June 2017. Factory management has completed all remediation work as per suggested DEA.	Corrected

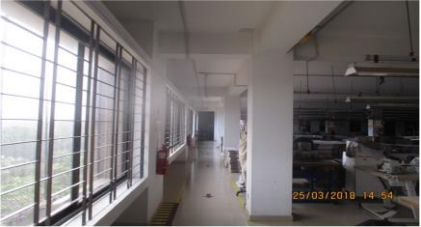
Item No	Accord Observation	Accord Recommendation	Accord Timeline	Final Action Plan	Final Timeline(DD/MM/ YYYY)	Comments after Physical Inspection	Progress Status	Pictorial Evidence
4	It is not mentioned that seismic and wind requirements of the 2006 BNBC were followed in structural documents.	Have a qualified structural engineer document compliance with the seismic and wind requirements stated in the 2006 BNBC.	6/29/2014 12:00:00 AM	Completed	10/02/2015	<p>On 15th Nov-2015: This issue will cover in design report.</p> <p>On 11th Dec-2017: DEA has been accepted from Alliance on 20th June 2017. As per accepted some remediation works (demolition work) were required to be implemented and during inspection it was observed that factory management completed all remediation works except in two toilet areas of 3rd and 6th floor. Factory management must complete all the remediation works.</p> <p>On 25/03/2018: DEA was accepted from ALLIANCE on 20th June 2017 considering wind and seismic loading. Factory management has completed all remediation work as per suggested DEA.</p>	Corrected

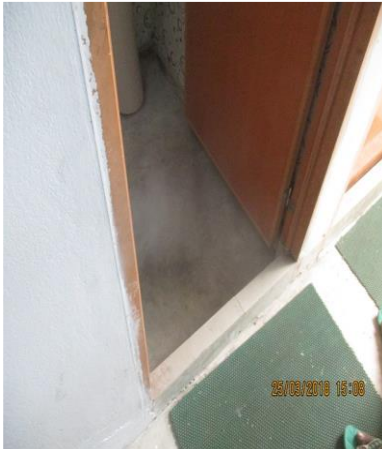
Item No	Accord Observation	Accord Recommendation	Accord Timeline	Final Action Plan	Final Timeline(DD/MM/YYYY)	Comments after Physical Inspection	Progress Status	Pictorial Evidence
7	Available structural documents do not indicate conformance with 2006 BNBC or other comparable applicable international model building code. A certification document by the structural engineer & architect states that the building is safe for factory operation according their structural design & construction supervision, but does not mention conformance with the 2006 BNBC or other comparable applicable international	Engage a qualified structural engineer to develop the required documents to confirm the structural integrity of the buildings. Documents must comply with Alliance Standard Part 8 Section 8.19 and 8.20.	6/29/2014 12:00:00 AM	Completed	18/03/2015	On 15th Nov-2015: This issue will cover in design report and as build drawing. On 11th Dec-2017: DEA has been accepted from Alliance on 20th June 2017. As per accepted some remediation works (demolition work) were required to be implemented and during inspection it was observed that factory management completed all remediation works except in two toilet areas of 3rd and 6th floor. Factory management must complete all the remediation works. On 25/03/2018: DEA was accepted from ALLIANCE on 20th June 2017. Factory management has completed all remediation work as per suggested DEA.	Corrected

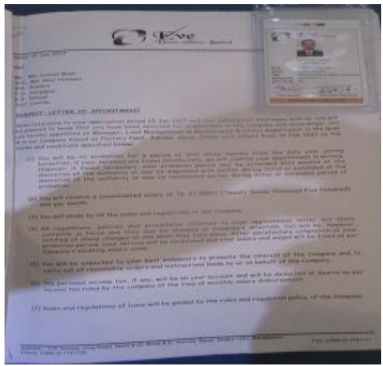
Item No	Accord Observation	Accord Recommendation	Accord Timeline	Final Action Plan	Final Timeline(DD/MM/ YYYY)	Comments after Physical Inspection	Progress Status	Pictorial Evidence
9	There is no designated representative(Factory Load Manager).	Designate a representative as the Factory Load Manager. The Factory Owner shall ensure that at least one individual, the Factory Load Manager who is located onsite full time at the factory, is trained in calculating operational load characteristics of the specific factory. The Factory Load Manager shall serve as an ongoing resource to RMG vendors and be responsible to ensure that the factory operational loads do not at any time exceed the factory floor loading limits as described on the Floor Loading Plans.	6/29/2014 12:00:00 AM	Completed (As per Alliance 3rd RVV on 18.07.2016)	08/06/2015	On 15th Nov-2015: The factory already engage an load manager. On 11th Dec-2017: This issue was corrected from previous inspection. Load manager has been appointed and he was present during inspection. On 25/03/2018: Corrected from previous follow up inspection. Load manager has been appointed. Load manager is present during inspection.	Corrected

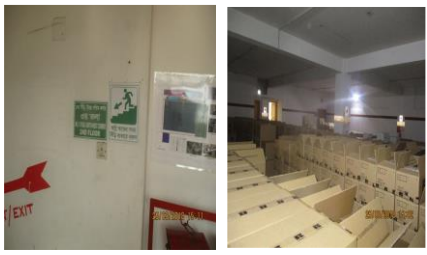
10	Floor load plan has not been prepared so far, but loading is within 42 psf.	Have a qualified structural engineer develop Floor Loading Plans per the requirements of Part 8 Section 8.20.5.3.	6/29/2014 12:00:00 AM	Completed (As per Alliance 3rd RVV on 18.07.2016)	18/03/2015	On 15th Nov-2015: load plans were not produced yet but they maintain loading 2kpa except store area in 5th & 3rd floor. Up to finalize design report the factory should be maintain 2kpa. On 11th Dec-2017: Load plan has been produced as part of DEA and accepted from Alliance. On 25/03/2018: Corrected from previous follow up inspection. Load plan was produced as part of DEA which was accepted by ALLIANCE.	Corrected

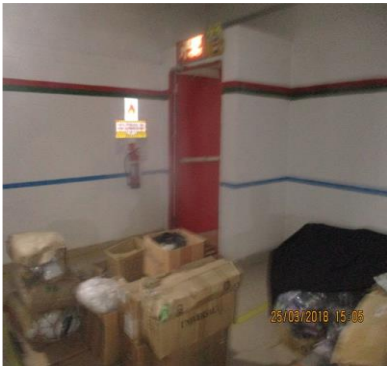
Item No	Accord Observation	Accord Recommendation	Accord Timeline	Final Action Plan	Final Timeline(DD/MM/YYYY)	Comments after Physical Inspection	Progress Status	Pictorial Evidence
11	No floor load plans have been developed.	Have a qualified structural engineer prepare load plans including the information required in Section 8.20 of the Alliance Standard. Floor load plans should be displayed on all levels of the building.	6/29/2014 12:00:00 AM	Completed	07/04/2015	<p>On 15th Nov-2015: load plans were not produced yet but they maintain loading 2kpa except store area in 5th & 3rd floor. Up to finalize design report the factory should be maintain 2kpa.</p> <p>On 11th Dec-2017: During inspection load plan was found posted in every floor plate and load was observed below allowable limit. Final load plan shall be implemented after completion of the remediation works.</p> <p>On 25/03/2018: Load plan was produced as part of DEA which was accepted by ALLIANCE. During inspection, load plan is found posted in every floor and load was observed below allowable limit. Factory management has completed all remediation work as per suggested DEA.</p>	Corrected

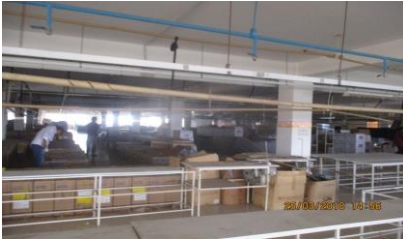
12	The areas are used for storage of work materials and work products are not clearly marked to indicate the acceptable loading limits.	Provide signage or the appropriate markings at all areas used for storage to indicate the acceptable loading limits detailed in the Load Plan.	6/29/2014 12:00:00 AM	Completed (As per Alliance 3rd RVV on 18.07.2016)	09/02/2015	<p>On 15th Nov-2015: load level marking were not produced yet but they maintain loading 2kpa except store area in 5th & 3rd floor. Up to finalize design report the factory should be maintain 2kpa.</p> <p>On 11th Dec-2017: During inspection load marking was observed in the storage areas.</p> <p>On 25/03/2018: Corrected from previous follow up inspection. Load limit marking is observed in storages area.</p>	Corrected
