FIRE SAFETY FOLLOW UP INSPECTION

Factory Name	Eve Dress Shirt Limited		Factory ID	11346
Address	Anowar Jung Road, Holding #219, Ward # 05, Block #A, Ashulia, Savar , Ashulia, Savar.			
Initial Inspection Date	31-Mar-2014		Report Received Date	
Date of 1st Follow-up	15-Nov-2015	Date of 2nd Follow-up	21-Mar-2016	
Date of 3rd Follow-up	13-Mar-2017	Date of 4th Follow-up	18-Jun-2017	
Date of 5th Follow-up	28-Sep-2017	Date of 6th Follow-up	14-Nov-2017	
Date of 7th Follow-up	14-Mar-2018	Date of 8th Follow-up	22-May-2018	
Date of 9th Follow-up	05-Mar-2019	Date of 10th Follow-up	06-Sep-2020	
Date of 11th Follow-up		Date of 12th Follow-up		
Date of 13th Follow-up		Date of 14th Follow-up		
Inspected by	Pantha Pallob Das

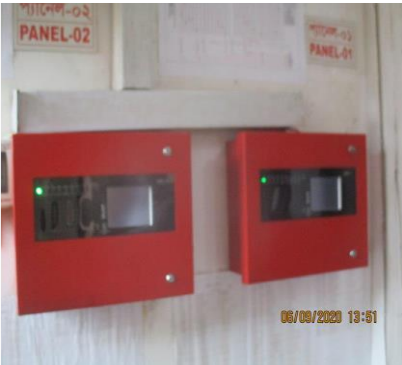
Item No	Accord Observation	Accord Recommendation	Timeline given by Accord	Comments after Physical Inspection	Supposed to complete(DD/MM/YYYY)	Final Action Plan (Factory)	Status on the date of Inspection	Pictorial Evidence
1	Panel power, zone light (to address zone of alarm), fault light (if anything is disconnected, etc.) on fire alarm control panel are functional for the Main Production building. There is no fire alarm and detection system for the utility building.	Install an automatic fire alarm and detection system for the utility building or expand the existing system. System shall comply with the Alliance Standard and NFPA 72. Consult a qualified fire protection engineer and/or authorized fire alarm company to design and install the system.	Jul 9 2014	<p>On 5-3-2019: Observations are not limited to, *Circuit breaker was not marked & open locked *Primary power feed line information was not posted near the panel. *Field devices (Pull stations, detectors) are not secured due to wiring connection. * Interfacing of fire pump controls was not as per Accord requirements. (Electric: Phase Loss, Phase Reversal, Motor Run; Diesel: Controller Mode, Common trouble) and authentic 3rd party certified/listed cable shall be used. *Pump run signal needs to be supervisory type. * Modules were placed inside Pull station boxes. * MCP location at 6th floor (North-West corner exit) was not visible (obstructed by door). * Detector was missing at roof landing and detector coverage shall be ensured for all locations.</p> <p>On 06/09/2020 (RSC): FADS is ready for full T&CVI.</p>	31-Dec-2016	Corrected	Pending Verification

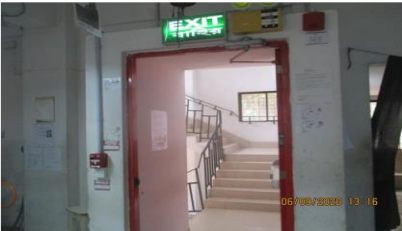
3	There are collapsible doors, rolling shutter & glass swinging doors with locking arrangements at each egress locations.	Replace all non-compliant doors and frames in the means of egress with doors that are listed, approved, automatic-closing, side-swinging, fire rated doors in compatible fire rated frames with latching panic hardware.	Sep 3 2014	<p>On 28/09/2017: Corrected. On 14/11/2017: Corrected On 14/03/2018: Corrected as per previous follow ups. On 22/05/2018: Corrected as per previous follow ups. On 5-3-2019: Corrected.</p> <p>On 06/09/2020 (RSC): Corrected.</p>	28-Apr-2016	Corrected	Corrected

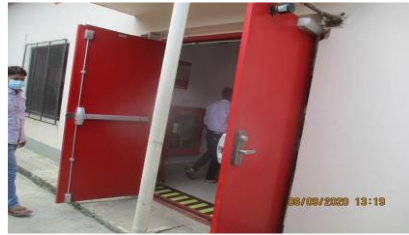
Item No	Accord Observation	Accord Recommendation	Timeline given by Accord	Comments after Physical Inspection	Supposed to complete(DD/MM/YYYY)	Final Action Plan (Factory)	Status on the date of Inspection	Pictorial Evidence
4	There are collapsible doors with locking arrangements at each egress locations.	Remove all hasps, locks, slide bolts, or other locking devices at the noted locations.	Jul 9 2014	On 14/11/2017: Corrected On 14/03/2018: Corrected as per previous follow ups. Shall be removed where exist. On 22/05/2018: Corrected as per previous follow ups. On 5-3-2019: Corrected. On 06/09/2020 (RSC): Corrected.	24-Mar-2016	Corrected	Corrected

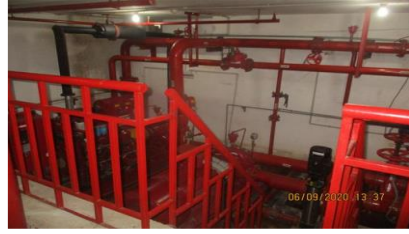
6	There is no stand pipe system in the main and ancillary buildings meeting the requirement of NFPA 14, 20, 22 and 25. No Class-I standpipe hose connection (65 mm) are installed at stairwells in each floor level including occupiable roof. 25 mm plastic hoses are connected with over head water reservoir. At roof hose pressure was negligible. Hose size, pressure and water capacity are not sufficient.	Install standpipe system at required locations. Standpipe system must comply with NFPA 14.	Sep 3 2014	On 22/05/2018: Reportedly modification work is going on. On 5-3-2019: Observations are not limited to, *A listed check valve is missing next to fire brigade connection. *Flow detectors are missing at standpipe risers. * Ball valve was initially found closed at top most of remote riser. On 06/09/2020 (RSC): Installation complete but factory is not ready for full T&CVI due to some reasons as noted in the Pre-T&CVI report.	15-Sep-2016	Corrected	In Progress

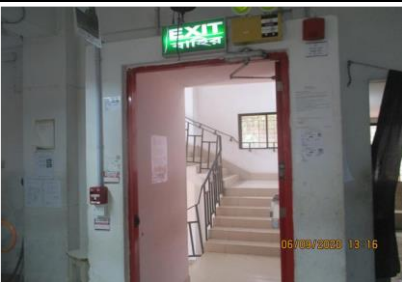
10	None of the stairs have handrails on both sides in any building of factory premises. No intermediate handrail is required as the width of those three stairs is 1.85 m (76 in.), 1.54 m (61 in.) and 1.29 m (51 in.) respectively. Handrail height of all stair cases is 813 mm.	Install handrails on both sides of the stair in accordance with Alliance Standard,Part-6,Section-6.9.2.4, 6.12.1.1 and 6.12.1.2.	Nov 26 2014	On 14/11/2017: Corrected On 14/03/2018: Corrected as on previous follow ups. On 22/05/2018: Corrected as on previous follow ups. On 5-3-2019: Corrected. On 06/09/2020 (RSC): Corrected.	21-Mar-2016	Corrected	Corrected

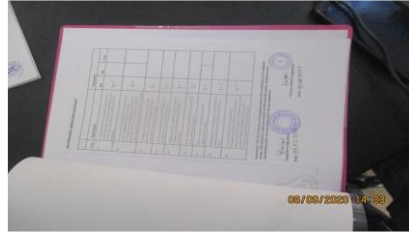
Item No	Accord Observation	Accord Recommendation	Timeline given by Accord	Comments after Physical Inspection	Supposed to complete(DD/MM/YYYY)	Final Action Plan (Factory)	Status on the date of Inspection	Pictorial Evidence
24	No plan or record of conducting periodic test for the emergency battery back up of illumination of exit sign was found as required by section 10.12.1.4 of Alliance Standard.	Develop a testing and maintenance program that ensures the emergency power for exit signs is tested at least once per year. If battery operated signs are used, these lights are tested on a monthly basis. Functional testing of battery powered signs is provided for a minimum 90 min once per year.	Jul 9 2014	On 14/11/2017: Corrected On 14/03/2018: Corrected as on previous follow ups. Exit signs shall be placed in exits instead of directional signs and directional signs shall be installed in floors where required. On 22/05/2018: Corrected as per previous follow ups. On 5-3-2019: Corrected. On 06/09/2020 (RSC): Corrected.	21-Mar-2016	Corrected	Corrected

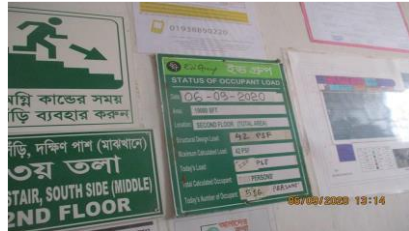
28	Floor level and stair designation signs are not provided at any floor in required locations.	Install signage adjacent to each stair door indicating the stair name and the floor level in English and Bengali at the noted locations.	Jul 9 2014	On 14/11/2017: Corrected On 14/03/2018: Corrected as on previous follow ups. On 22/05/2018: Corrected as per previous follow ups. On 5-3-2019: Corrected. On 06/09/2020 (RSC): Corrected.	21-Mar-2016	Corrected	Corrected

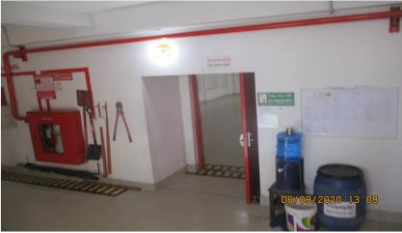
Item No	Accord Observation	Accord Recommendation	Timeline given by Accord	Comments after Physical Inspection	Supposed to complete(DD/MM/YYYY)	Final Action Plan (Factory)	Status on the date of Inspection	Pictorial Evidence
42	New Finding (8th Follow-up): All paths of egress are not provided with compliant means of illumination. Emergency light not illuminated during testing (burned out, broken, etc.).	Maintain adequate illumination at means of egress path as per accord standard & replace burned out/damaged light regularly.	Within 1 month	On 22/05/2018: New Finding. On 5-3-2019: Corrected. On 06/09/2020 (RSC): Corrected.	22-Jun-2018	Corrected	Corrected
