**ELECTRICAL SAFETY FOLLOW UP INSPECTION REPORT (9TH)**

| <b>Factory Name</b> | <b>Eve Dress Shirt Limited</b> | | | | | <b>Note:</b> |
| <b>FACTORY ID</b> | <b>11346</b> | <b>ELECTRICAL SAFETY INSPECTION DATES</b> | | | | <b>Other Factory:</b> |

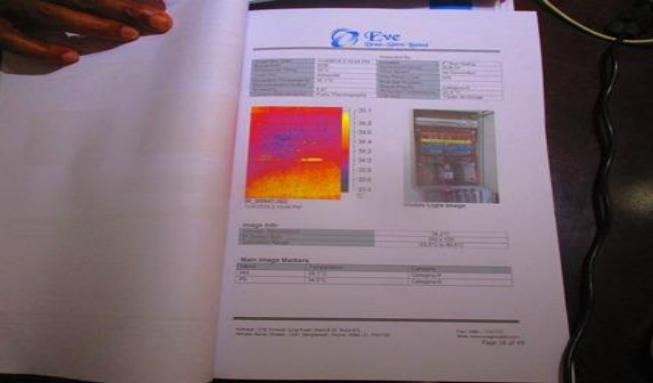
| Item No | Accord Inspection Observation | Accord Action Plan (Recommendation) | Accord Time line (given in report) | Comments from Accord (After Physical Inspection) | Final Timeline (Approved timeline) | Final Action Plan (Factory) | Progress Status (On the date of inspection) | Pictorial Evidence |
|---|--|---|---|--|---|---|---|--|
| 54 | New Finding: Ambiguity found in thermographic scan report (protector glass was not removed while doing scan for report preparation). | Thermography survey shall be conducted in adequate manner on entire electrical system in the facility at least twice in a year. And the remediation suggestions mentioned in the report shall be carried out. | 1 Month | <b>On 05/03/2019:</b><br>Corrected | '30/06/2018 | | Corrected | |
